STILLING BASIN PERFORMANCE STUDIES  
AN AID IN DETERMINING RIPRAP SIZES

Hydraulic Laboratory Report No. Hyd-409

Commissioner's Office--Denver  
Division of Engineering Laboratories  
Hydraulic Laboratory Branch  
Hydraulic Structures and Equipment Section  
Denver, Colorado  
February 23, 1956

Subject: Stilling basin performance studies--An aid in determining  
riprap sizes

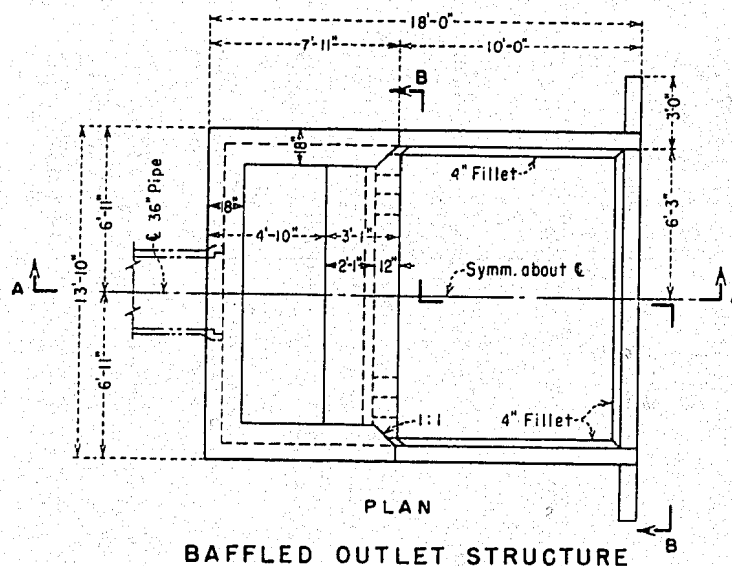
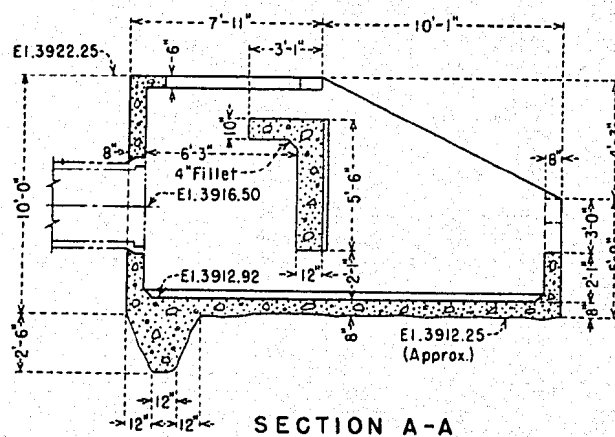
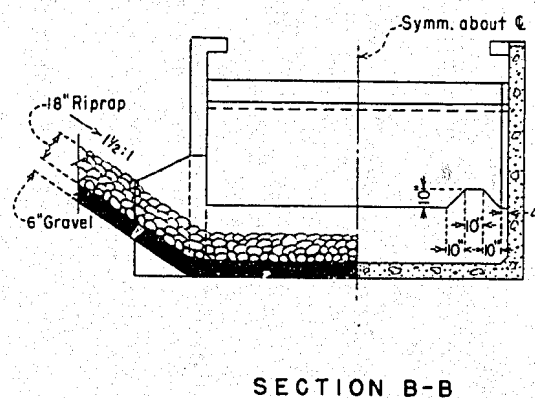
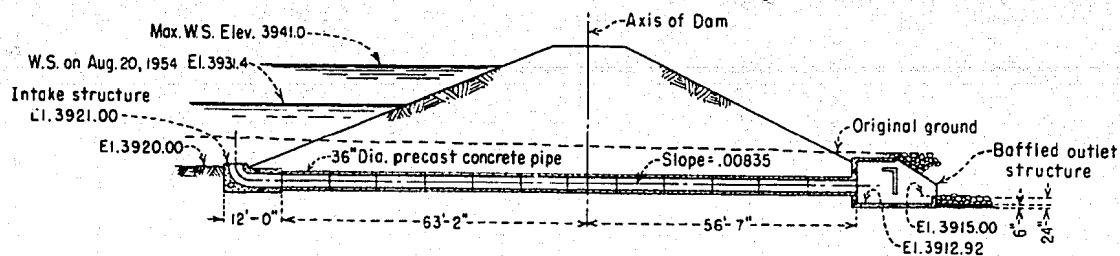
FIGURE 1

The Picacho South Dam outlet works structure, designed for a maximum discharge of 165 second-feet, is shown on Figure 1. The dimensions agree closely with those recommended from the hydraulic model tests, Figures 2 and 3. (Interpolate between 151 and 191 in Column 3 of Figure 3.) The Picacho North Branch Dam outlet works, Figure 4, designed for a maximum discharge of 275 second-feet, was also constructed according to the hydraulic model test recommendations. (Compare dimensions in Figure 4 with values interpolated between 236 and 339 in Column 3 of Figure 3.) The design criteria for structures of this type are discussed in Hydraulic Laboratory Report No. Hyd-399.

RIO GRANDE PROJECT  
LAS CRUCES DIVISION - NEW MEXICO  
PICACHO SOUTH DAM  
OUTLET WORKS

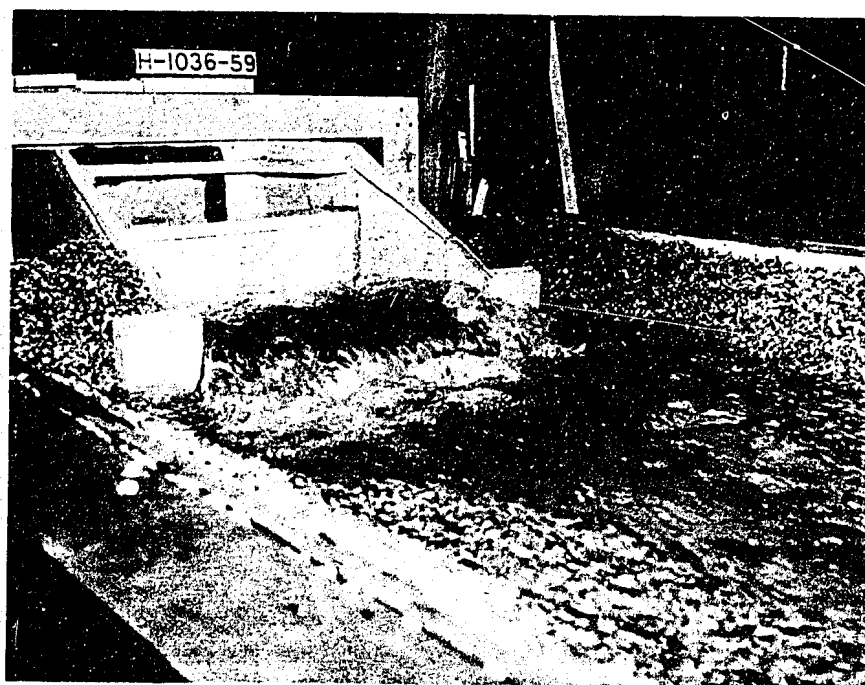
It should be noted in Figure 6 that the tail water is low with respect to the stilling basin. Therefore, the velocity over the end sill is considerably lower than the velocity striking the riprap. For the North Dam basin having a sill length of 15.5 feet, a critical depth of 1.5 feet over the end sill and a discharge of 210 second-feet, the critical velocity would be 7.6 feet per second, requiring riprap, Figure 11, about 9 inches in diameter. Further acceleration of the flow by a drop from the end sill to the tail water surface of 2 feet, Figure 6, would result in a velocity of about 14 feet per second, requiring riprap about 30 inches in diameter. Thus, the importance of matching the basin elevation to the probable tail water elevation is evident. In the case of the North Dam basin, however, the tail water elevation was, no doubt, higher before the riprap was lost.

North Branch Dam outlet works structure discharging  
210 second-feet (80 percent of maximum).

Hydraulic model discharging maximum discharge  
under similar conditions of head and tailwater.

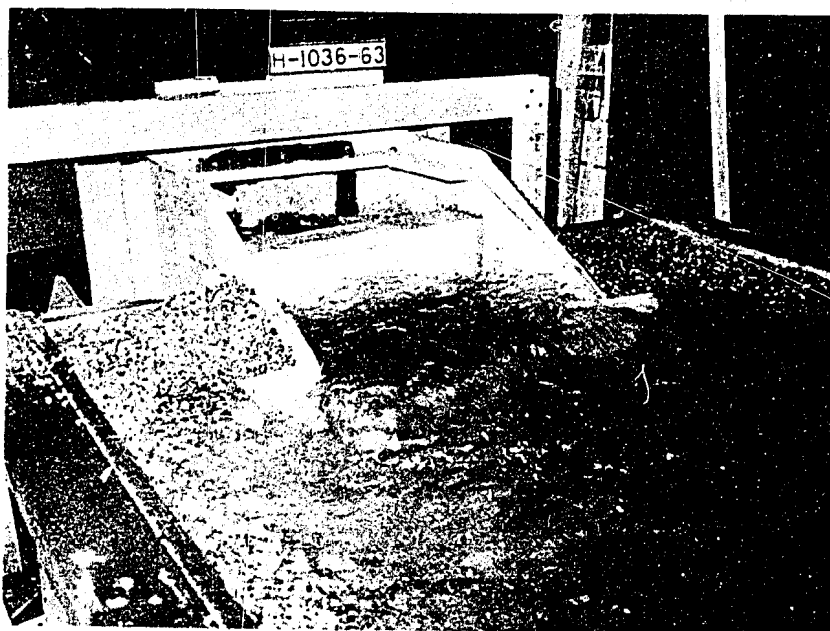
South Dam outlet works structure discharging 130 second-feet (80 percent of maximum).

Flow appearance in model for the same conditions.  
Note similarity both upstream and downstream  
from vertical baffle.

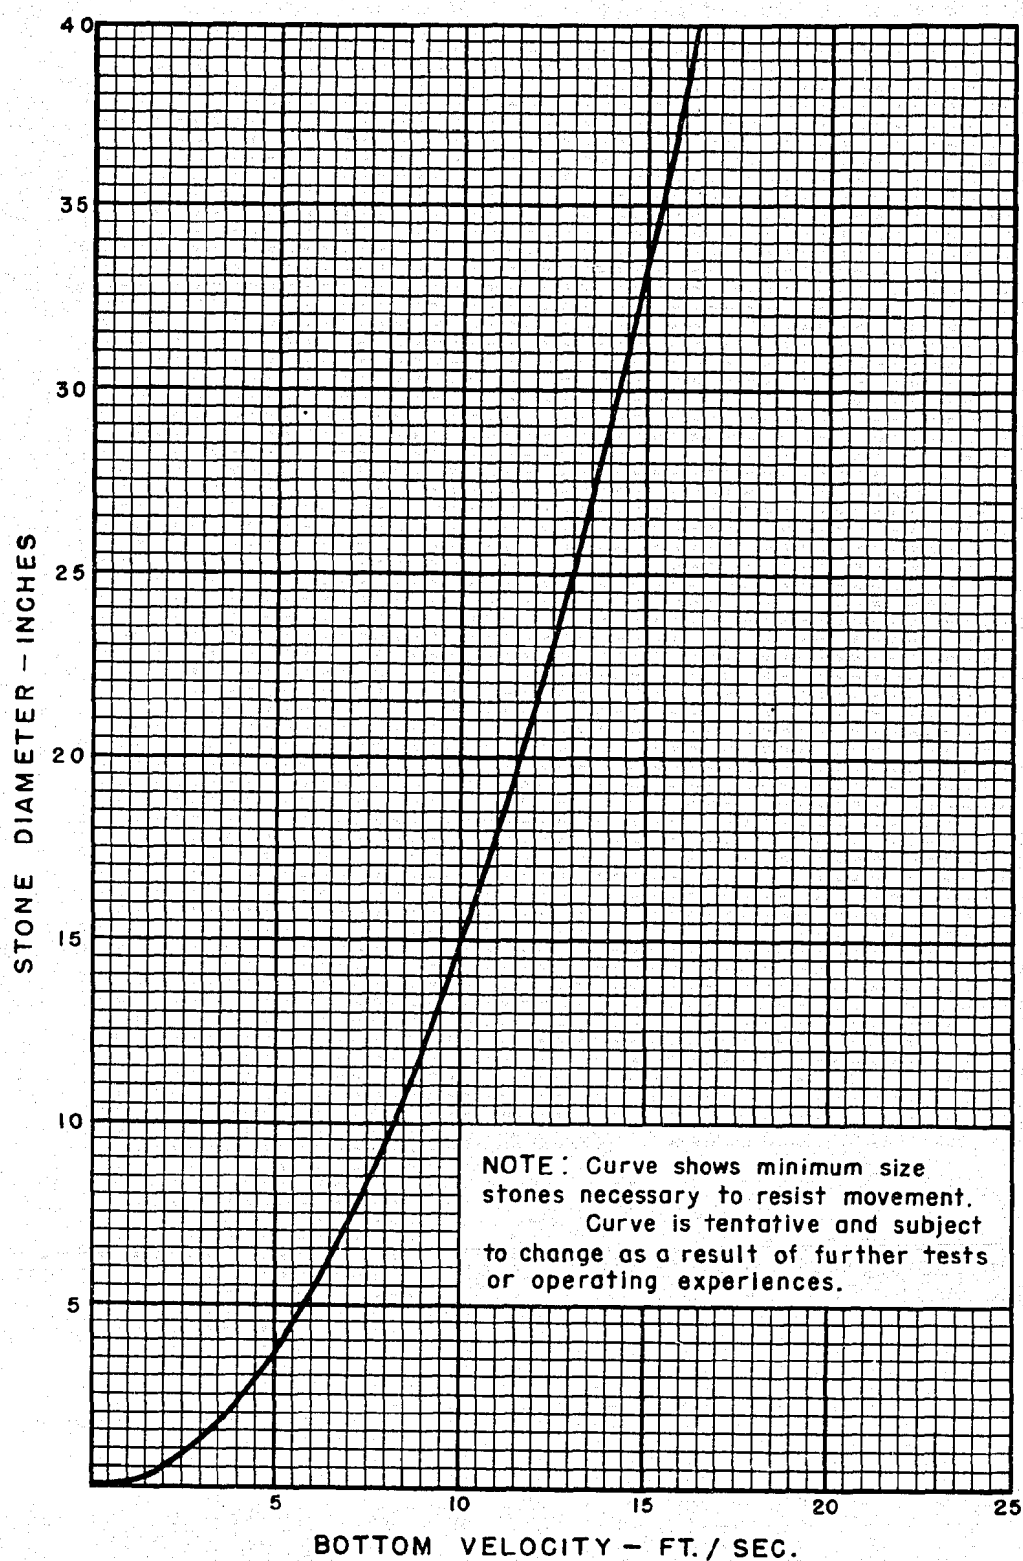
FIGURE 11

As a further check on the riprap size necessary to withstand the erosive forces the curve of Figure 11 indicates the velocity at which individual stones begin to move. These data apply strictly to uniform channels having uniform velocity distribution; the velocity at which the stones begin to move is the bottom velocity in the channel, not the average velocity. Using this graph for the case at hand, the critical stone size is about 20 inches. This checks the equivalent 9- to 18-inch stone size, used in the model tests, to a reasonable degree since some of the model riprap did move.

The velocity over the end sill of the South Dam basin is much lower than at the North Dam, being only about 5 feet per second. According to the curve of Figure 11, the riprap size required would be about 4 inches. Since the riprap sizes, given in Specifications No. DC-4002 for the South Dam outlet are the same as for the North Dam outlet, the stone size in this case was sufficiently large to resist movement.

A suggested minimum size for riprap is given by the curve in Figure 11. The curve indicates, over most of its range, that doubling the flow velocity leaving a structure makes it necessary to provide riprap about 4 times larger in nominal diameter or 16 times larger in volume or weight.

TENTATIVE CURVE TO AID IN DETERMINING RIPRAP SIZES

It is recommended that riprap sizes for future projects be specified using Figure 11 as a guide. It is felt that this curve, even though it has not been fully proven, will provide a starting point for development of an accurate method to determine minimum stone sizes. The

It is also recommended that laboratory and field tests be requested to confirm the accuracy of the velocity versus stone size relation given in Figure 11.
